Conditioning System

A case study for cooling tower application

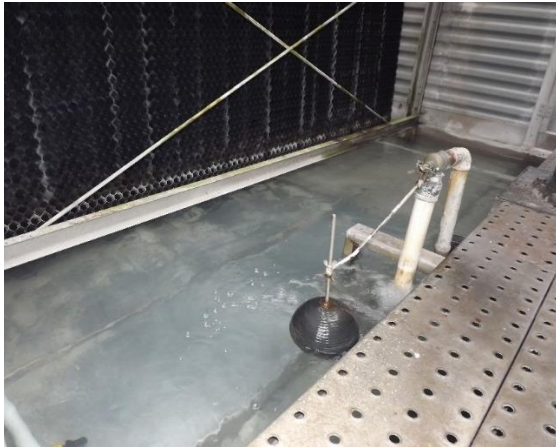
Picture of the cooling tower basin and filter media, conditioned by the system. Scale has dropped off and the water is completely translucent and free of cloudiness. No odors are perceived and no algae growth has been observed anywhere in the tower.

- There is a noticeable break down of previously formed hard scale deposits, which are now falling into the tower's basin where the system catches them and filters them out.

- Progressively, the cooling tower fill is becoming cleaner over time. It is expected that the yearly cleanup of the media would not be necessary.

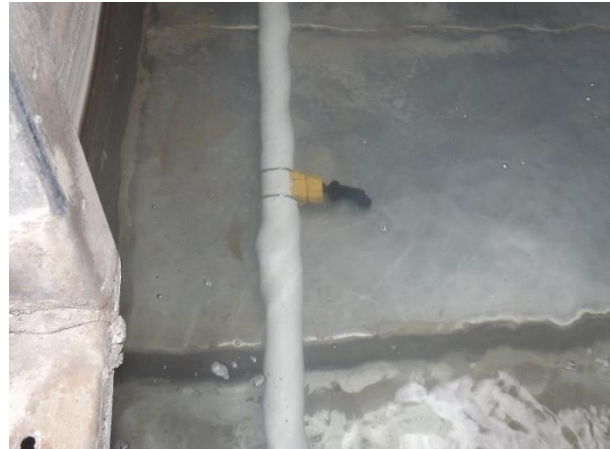
Return piping with directional jets, adjusted to prevent stagnant areas and particle build up in basin.

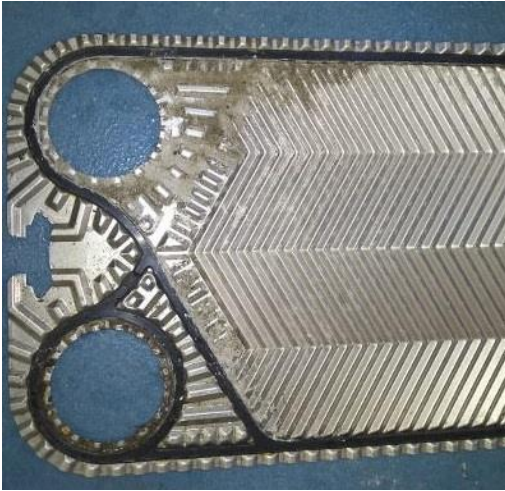
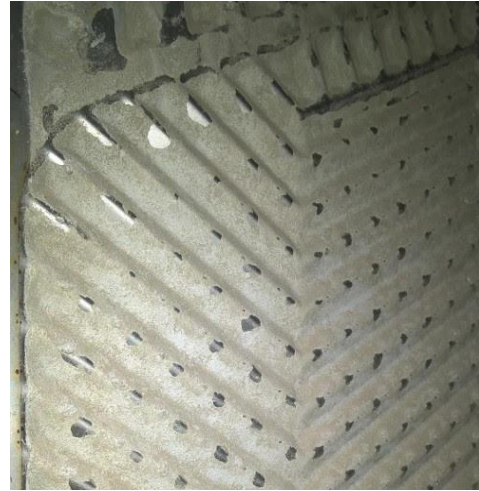
The heat exchanger was opened for inspection of the plates 10 months after installation of the conditioning system. These pictures, taken as soon as it was opened and had not been maintained or washed yet, show the condition of both sides of the plate. Our client noted they are extremely clean and the small amount of hard water deposits on them flake off easily when touched. High pressure wash and acid bath was not required to clean them.

- Observed differential pressure readings in the plate heat exchangers have been stable for months and have not had to do any maintenance. A savings of 48 hours on maintenance activities and associated production downtime to maintain the heat exchanger. This was every 3 months and now it is a once a year activity.
